Sixty-three *Wreck Tours* have passed come and gone since we visited a Castle-class trawler wreck off Dartmouth. **JOHN LIDDIARD** feels that enough time has passed for him to tackle another one in the same part of the world. His tour is illustrated by **MAX ELLIS**

THE PICTON CASTLE

THE *PICTON CASTLE*, trawler/minesweeper. BUILT 1911, SUNK 1917

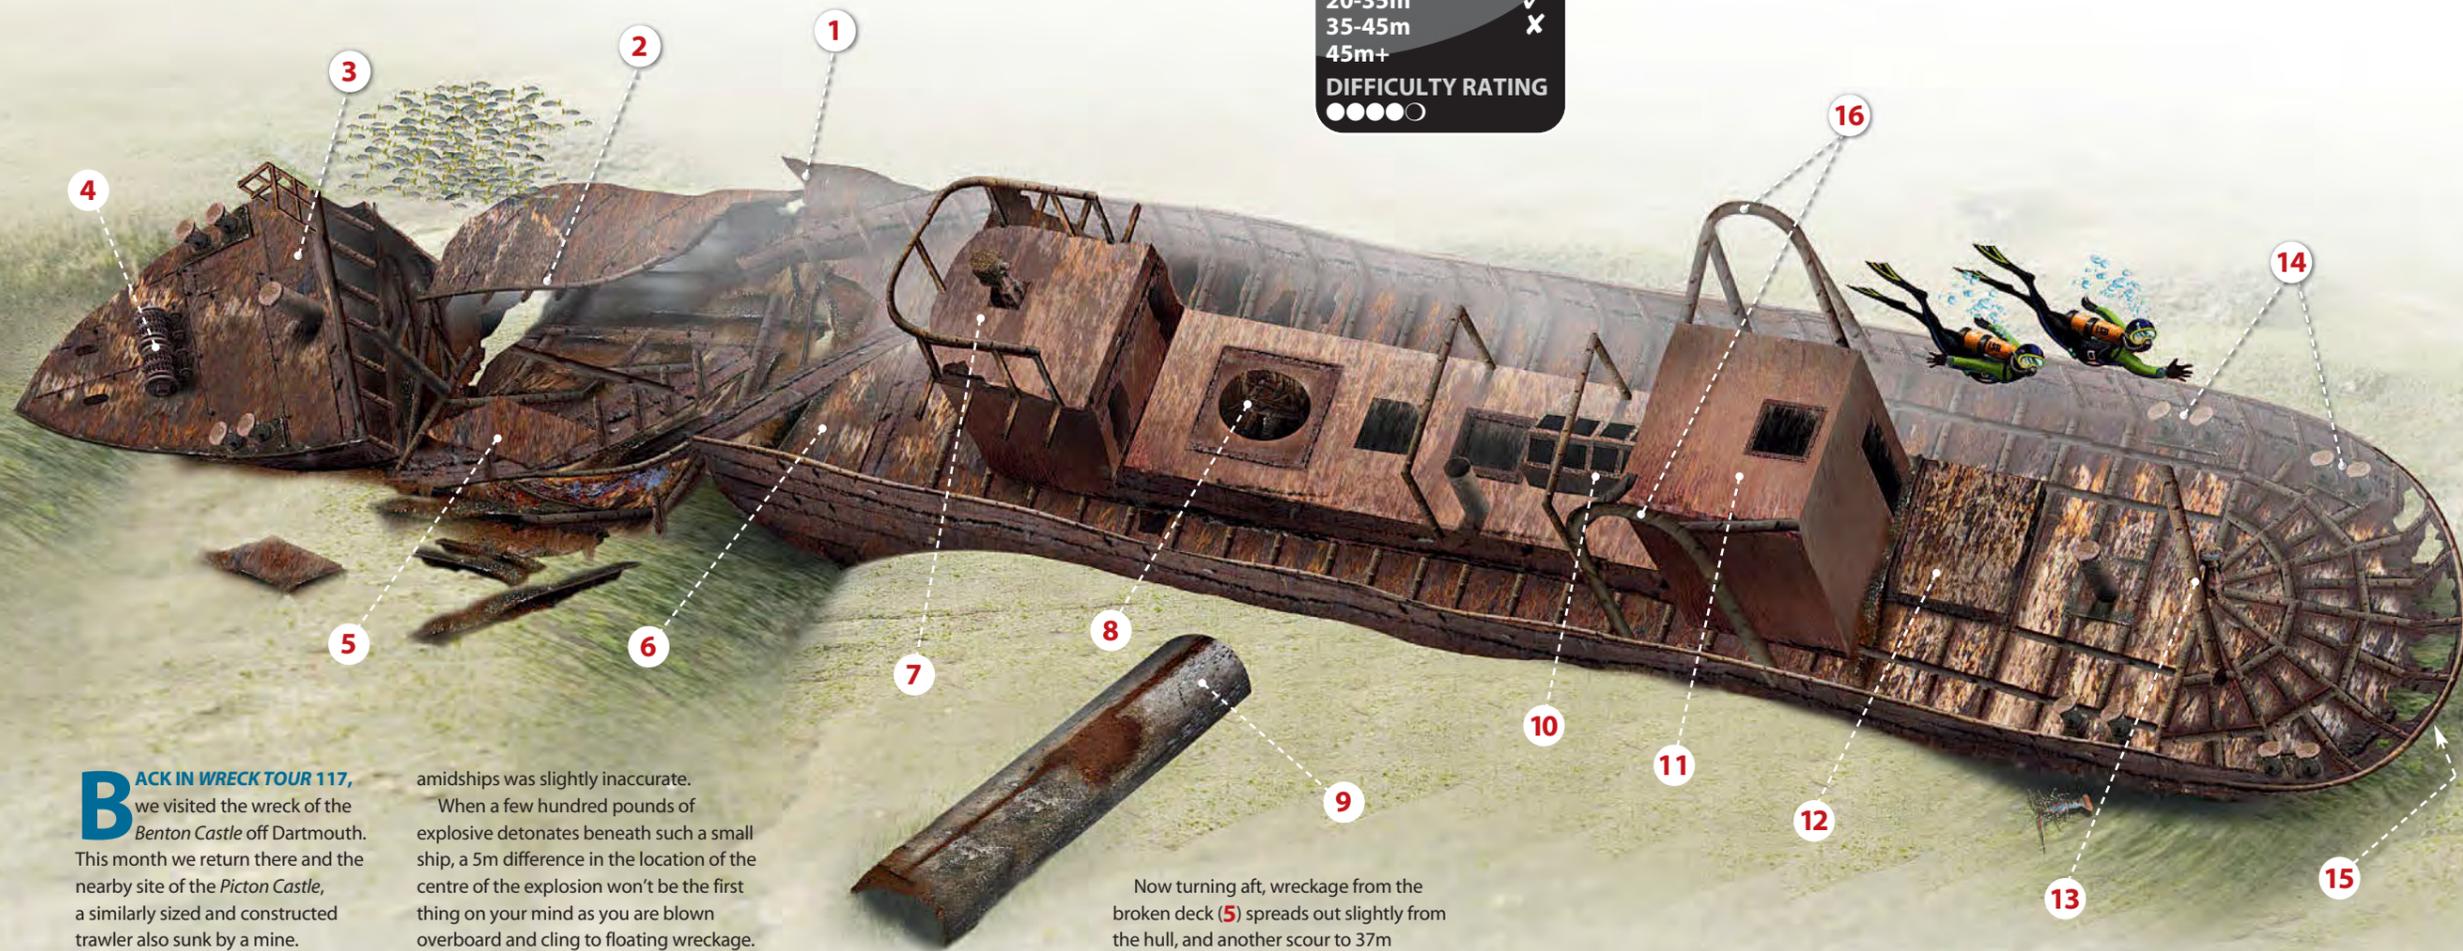
amidships was slightly inaccurate. When a few hundred pounds of explosive detonates beneath such a small ship, a 5m difference in the location of the centre of the explosion won't be the first thing on your mind as you are blown overboard and cling to floating wreckage. The wreck sits on a silty seabed at 35m and is well over to port, with the port side of the deck almost in the silt, and the starboard rail at 32m. Turning forwards past the collapsed plates of the hull (2), the wreck becomes intact again on reaching the forecastle (3). The bow is tilted even further to port, with a mast-foot at the back, the usual pairs of bollards to either side and a small anchor-winch (4) close to the stem. Beneath the bow, the seabed is scoured to 37m.

Now turning aft, wreckage from the broken deck (5) spreads out slightly from the hull, and another scour to 37m indicates just how strongly the tide rips through the broken area of the wreck once slack water is over. The hull and deck now gains some structure again (6). The helm (7) is located on top of a small deck-house, barely distinguishable beneath a dense covering of plumose anemones. This is surrounded by an intact railing, suggesting that the helm was originally in the open, or perhaps protected only by a small wooden shelter that is now long decayed. Ribs sticking out on either side of this platform suggest that the main deck on either side may also have been sheltered by a wooden structure. Continuing aft, a slightly raised section spanning the middle of the deck runs above the stoke-hold and engine-room. An oval hole (8) marks where the funnel was attached. It is now filled with debris, but would originally have led to the forward end of the boiler. The funnel (9) lies on the silt out from the starboard side of the wreck. The raised section continues above the boiler, past a pair of small hatches and a tubular ventilator to a further raised skylight (10) above the engine. The *Picton Castle* was fitted with an

Behind the engine-room is a larger deck-house (11) with the arched frames, or trawl-gallows, to either side and a doorway at the back.

Our tour is now at the stern deck of the wreck. Here a square hatch in the centre of the deck is surprisingly still covered (12). Another mast-foot is located on the centre-line, with pairs of bollards to either side.

The steering mechanism is a simple T (13). If you look closely, against the gunwales on either side are pulleys that would have routed cables from the T along the sides of the deck and forward to the helm.

Also notable is a changed pattern of deck-beams, from a grid that runs forward to a radial pattern that runs around the stern. Aft of the steering are further pairs of bollards (14).

Continuing "over" the stern, the rudder-frame and an iron propeller remain in place

(15), rising from the silt as another 2m-deep scour shows where the tide rips round the stern of the wreck.

With our tour over, it is time to ascend. Returning a few metres forward along the starboard side of the deck, the starboard trawl-gallow (16) marks the shallowest point of the wreck, and a good place to release a delayed SMB for a drifting decompression.

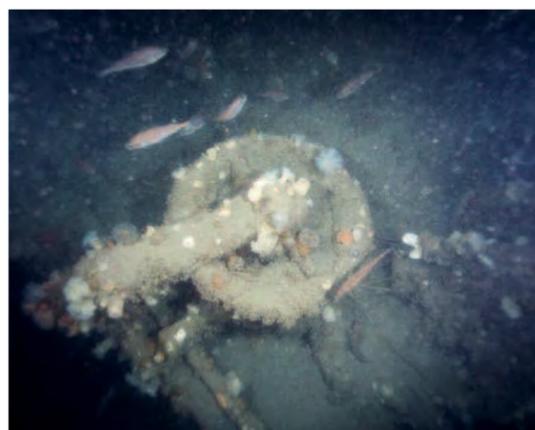
Below left: Pulley to route the steering cable.
Below: A lobster, probably as old as the wreck is!

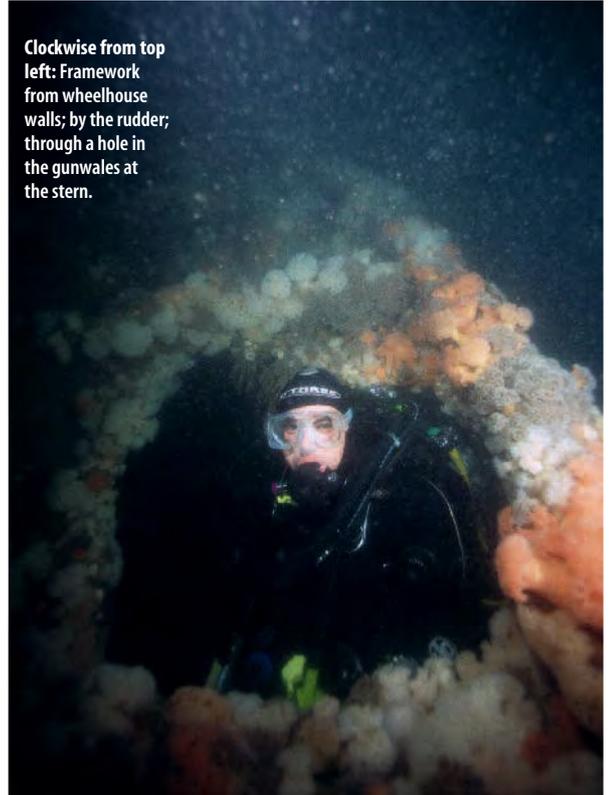
Clockwise from top left: Framework from wheelhouse walls; by the rudder; through a hole in the gunwales at the stern.
